Proper Position for the Pilot Assembly for the ULN Residential Gas Atmospheric

## Technical Service Department

Technical Service Bulletin

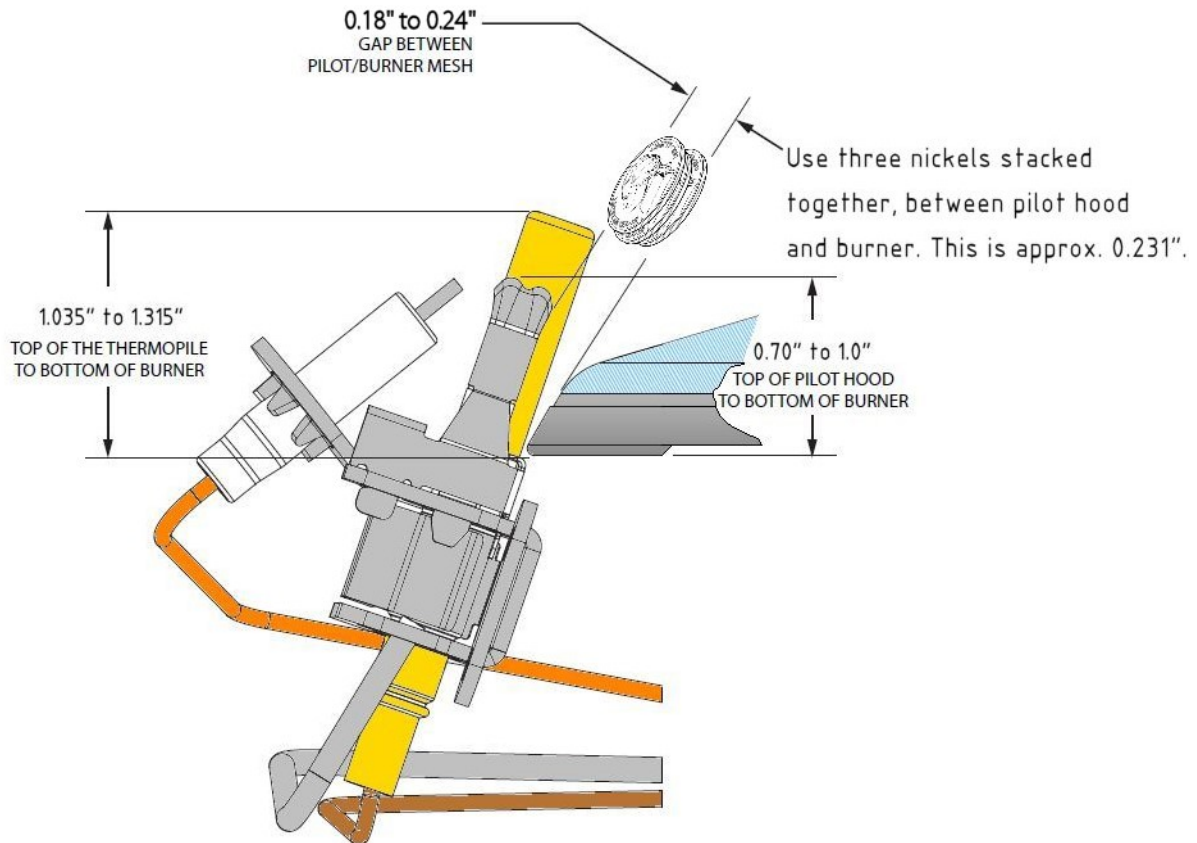
**Pilot Location Details**

Rheem has become aware that in limited production quantities, the ULN atmospheric models may experience pilot outages causing intermittent operation of the burner. If you experience this issue, please check pilot's position using the following information.

The above picture illustrates the proper position for the pilot assembly for the ULN residential gas atmospheric heaters with mesh type radiant burner. Pilot assembly out of position can create problems of the water heater staying lit.

Once the pilot is mounted, ensure the screws are tight and the spacing is correct. Ensure the pilot bracket assembly is also mounted securely.

- Just under a  $\frac{1}{4}$ " gap between pilot hood and burner mesh.  
\*(you can use 3 nickels, or 3 quarters.)
- Approximately  $\frac{7}{8}$ " top of pilot hood to bottom of burner.
- Approximately  $1 \frac{3}{16}$ " from top of thermopile to bottom of burner.

After insuring the position of the pilot is to the correct gap dimensions, the ignition process can be followed per the instructions on the unit or in the Use & Care manual. Any gas valve error code related to the pilot position will clear and allow for proper burner operation.
