Explanation:

The alarm code A108 will sound when condensate rope sensor gets wet. The rope portion of the sensor is positioned in the condensate drain which is located in the heat pump area beneath the fan filter. The other end is connected to the controller. When the heat pump is running it creates condensation. During normal operations, that condensation should drain freely and flow out of the drain pan port and through the PVC drain line to the outside or to a flood drain. When the line is clogged or restricted, condensation will back-up and make contact with the sensor then sound the alarm.

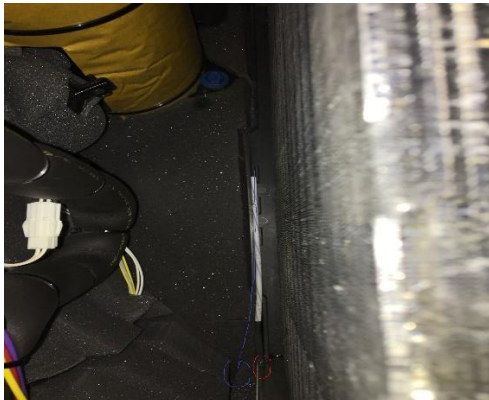
- --To check for a clogged drain line, disconnect the PVC drain line from the drain pan port, examine the drain line and flush if necessary.
- --To check the drain pan, remove lid. There are 4 screws around the lid and 4 screws on top holding the lid down. After removing lid, examine the drain pan, which will be inside the heat pump area underneath the filter. Clean and dry pan if needed.
- --If **pan** and **condensate sensor** are dry and there are no obstructions found, the problem may be with the condensate sensor or the controller (Power Control Board).

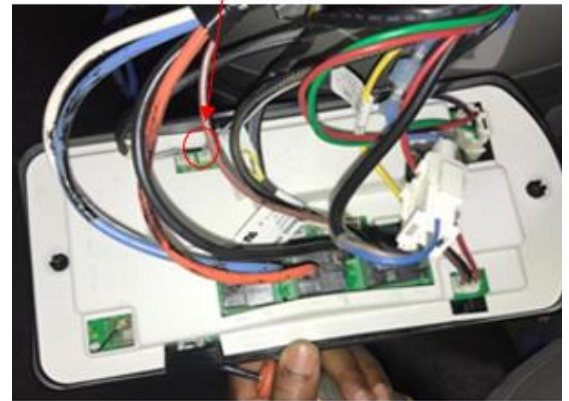
Control Board Assembly Wiring

- If this is a new install, the culprit is likely the condensate sensor or controller (Control Board).
- In order to determine if a defective rope, disconnect the condensate sensor from the controller.
- To disconnect the sensor locate the small pry hole above the screen then pry the face plate off with the flathead screwdriver.
- Remove the 2 Philips head screws then the controller will fall from unit.
- Please find sensor **here** the connector with 2 grey wires.

- After disconnecting sensor power unit up and run in heat pump mode for 24hrs.
- If the A108 does not return, the issue is a defective condensate rope and the condensate rope should be replaced
