FV Sensor SP20172/ Low Resistance

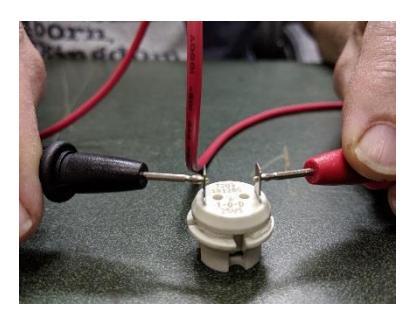
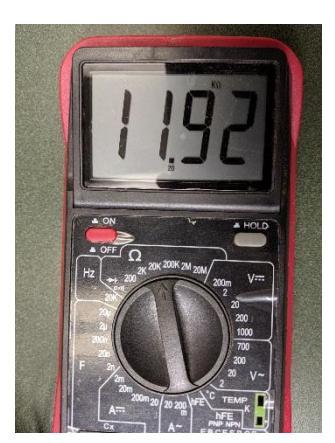
If given an FV sensor error for any FV sensor (SP20172): Disconnect the wires from the gas valve to the flammable vapor sensor

- 1. Set your multi-meter to the correct resistance Ω setting
- 2. Insert your meter leads into the backside of the Molex connector reduce risk of compromising the Molex connector end, which connects to the gas valve.
- 3. If the resistance reading is below 13K Ω for both flammable sensor and wiring harness, proceed to test sensor only.
- 4. Reset gas valve after replacing sensor (See document AP15048-1 for GCV reset procedure)
- 5. Remove flammable vapor sensor from the plastic bracket on the base ring of the water heater and disconnect both wires from the sensor.
- 6. Place your multimeter leads on the sensor terminals and take resistance readings of sensor alone. If sensor reads below 13K Ω , replace sensor

NOTE: When checking resistance of the sensor, check with wires attached to sensor with sensor unplugged from the valve. If you get an invalid reading, then check across sensor only.

- If wires and sensor check are valid, then proceed to GCV reset procedure (See document AP15048-1 for GCV reset procedure) Sensor is not defective.
- If wire harness or sensor checks are invalid, then replace appropriate/corresponding part.
